**Flood Control Project Maintenance
Levee Inspections**

Maintenance Issue Types Only, Levee Inspection Report By Mile - Fall 2015

Sutter Maintenance Yard Murphy Slough at M&T Ranch

Waterway	Bank	Unit Miles	Inspection Start/End	Inspector
Unit No. 01 Murphy Slough at M&T Ranch	Left	0.83	09/23/2015 09/23/2015	Bob Duffey

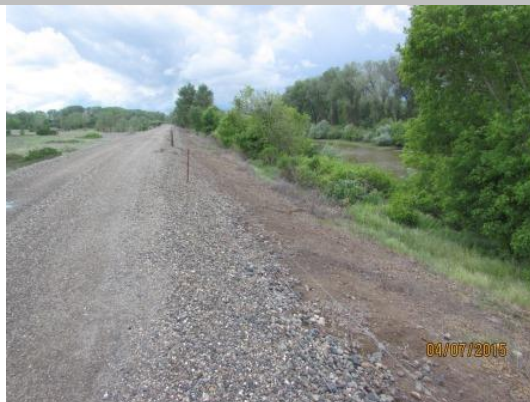
Photo 1 of 2 : FA_2015_ST0014_372_5_20150910_00003.jpg

LM Start	0.00	Rating **	A	Issue No.	5
LM End	0.83	Issue Type +	Ma	Location *	WS
Category	Earthen Levee			GPS Latitude/Longitude	
				Start	End
Item	Vegetation			39.666988 °	39.670695 °
				-121.960993 °	-121.970383 °
DWR ID	DWR_NA0014_01_s _ 2012_5				
Action/Comments					
Control annual grass and weeds on the levee slopes and easements. Inspector Comments: Sutter Yard sprayed the slope to remove the vegetation.

View of the vegetation along the waterside slope.

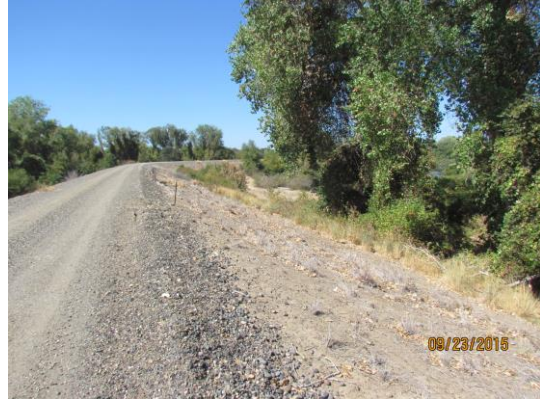
Photo 2 of 2 : FA_2015_ST0014_372_5_20151012_00004.jpg

LM Start	0.00	Rating **	A	Issue No.	5 (cont)
LM End	0.83	Issue Type +	Ma	Location *	WS
Category	Earthen Levee			GPS Latitude/Longitude	
				Start	End
Item	Vegetation			39.666988 °	39.670695 °
				-121.960993 °	-121.970383 °
DWR ID	DWR_NA0014_01_s_2012_5				
Action/Comments					
Control annual grass and weeds on the levee slopes and easements. Inspector Comments: Sutter Yard sprayed the slope to remove the vegetation.

View of the slope with no vegetation.

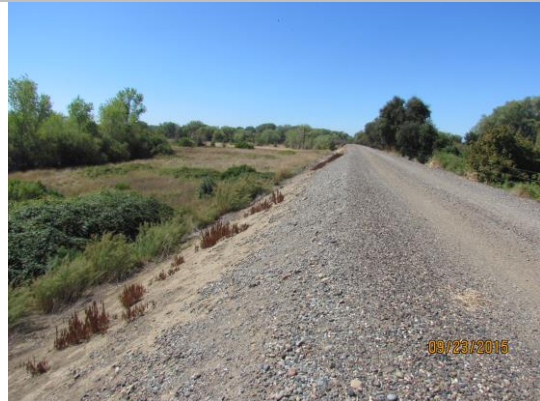
Photo 1 of 1 : FA_2015_ST0014_372_7_20151012_00005.jpg

LM Start	0.12	Rating **	A	Issue No.	7
LM End	0.83	Issue Type +	Ma	Location *	LS
Category	Earthen Levee			GPS Latitude/Longitude	
				Start	End
Item	Vegetation			39.666813 °	39.670697 °
				-121.961058 °	-121.970385 °
DWR ID	DWR_ST0014_01_f_2015_7				
Action/Comments					
Control annual grass and weeds on the levee slopes and easements. Inspector Comments: Sutter Yard sprayed the slope to remove the vegetation.

View of the slope with no vegetation.
